INSPECTION REPORT

For the Property at:
Example Property Dr.
Columbus, OH 43215

Inspection Date: Wednesday, December 1, 2021

RE: Report No. 4467 Example Property Columbus, OH 43215

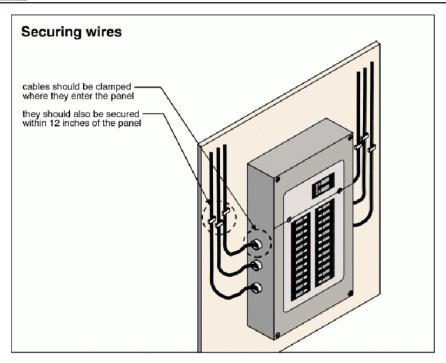
Condition: • Not well secured

Anywhere a wire cable assembly enters a metal enclosure, a connector clamp is required to secure the cable (called strain relief) and to protect the cable from chafing against the enclosure

Implication(s): Electric shock | Fire hazard

Not well secured

Location: Garage attic **Task**: Secure with clamp(s)

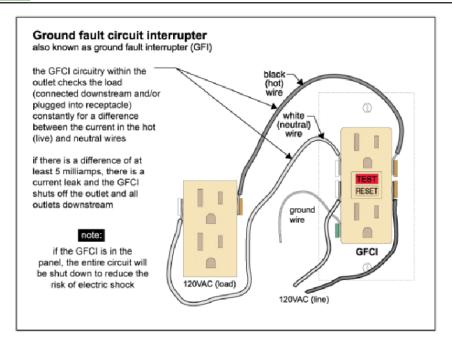
Condition: • GFCI/GFI needed (Ground Fault Circuit Interrupter)

GFCI protected outlets are required at all wet locations: basements, bathrooms, kitchens, outdoors, garages, etc.

Implication(s): Electric shock

GFCI/GFI needed (Ground Fault Circuit...

Task: Add GFCI protection

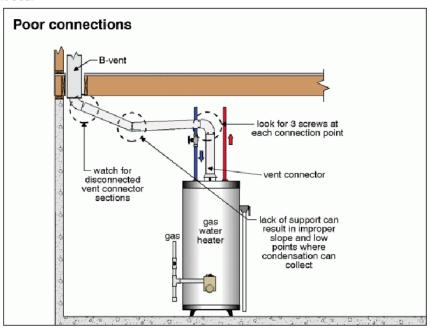
Condition: • Poor connections

Implication(s): Hazardous combustion products entering home | Equipment not operating properly

Location: Water heater
Task: Secure/Attach/Seal

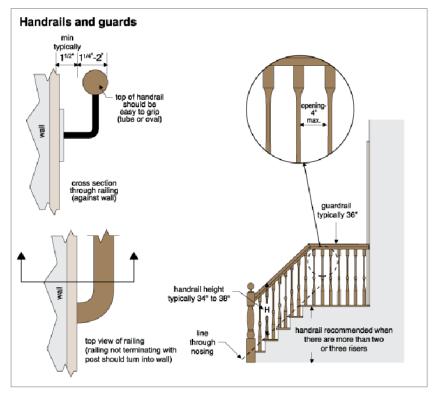
Condition: • Missing
Implication(s): Fall hazard
Location: Basement staircase

Missing

Task: Install guardrail

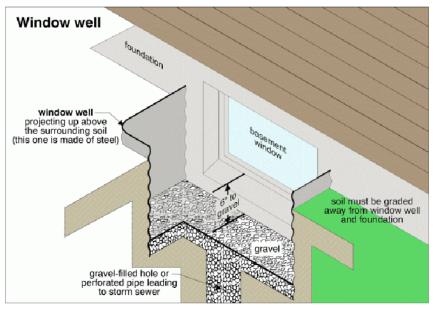
7. Condition: • Missing

-Window wells will allow for grading soil away from the wall and alleviate water intrusion concerns **Implication(s)**: Chance of water damage to structure, finishes and contents | Material deterioration

Missing Missing

Task: Install window wells

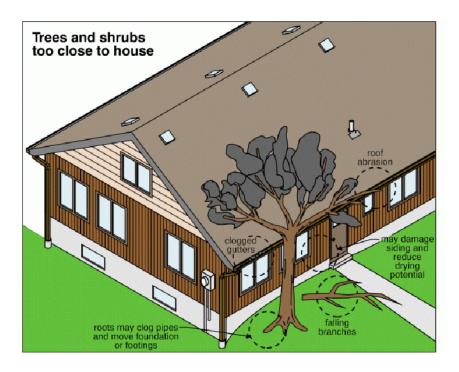
8. Condition: • Trees or shrubs too close to building

Shrubs hold moisture against the exterior, contributing to wall erosion, moisture intrusion and pest infestation **Implication(s)**: Chance of pests entering building | Material deterioration | Chance of water damage to structure, finishes and contents

Task: Remove

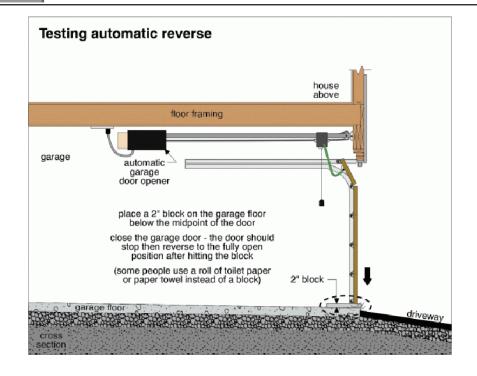
12. Condition: • Fails to auto reverse

The auto-reversing mechanism is a safety feature that causes the door to reverse coarse when it hits an obstruction while closing, and should require very little resistance to be actuated.

Task: Service/Adjust

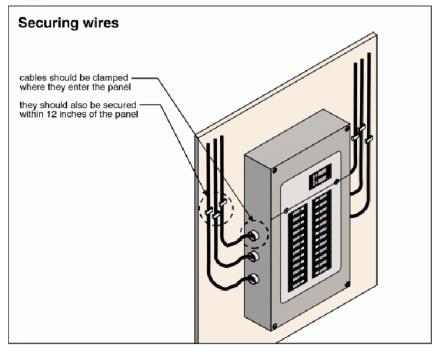
14. Condition: • Not well secured

Implication(s): Electric shock | Fire hazard

Location: Garage attic **Task**: Secure with clamp(s)

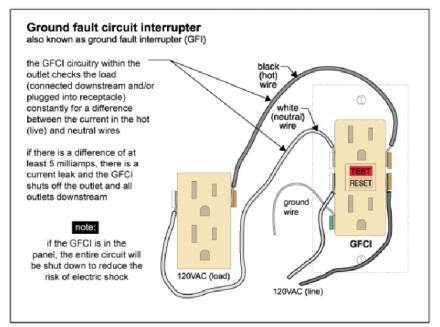
15. Condition: • GFCI/GFI needed (Ground Fault Circuit Interrupter)

Task: Add GFCI protection

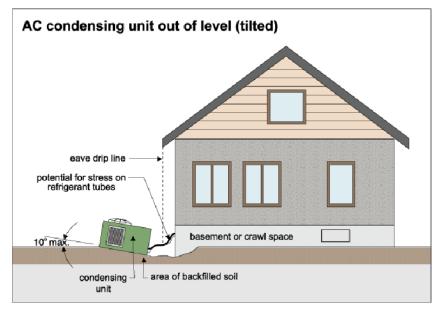
21. Condition: • Out of level

Implication(s): Damage to equipment | Reduced system life expectancy

Task: Service

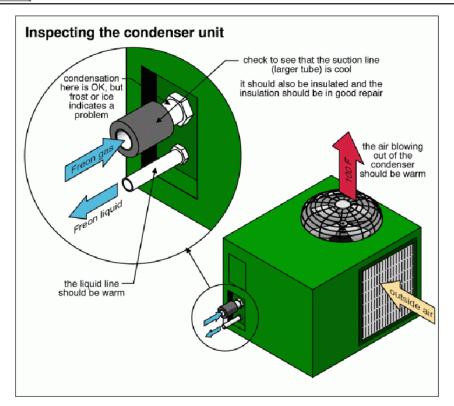
22. Condition: • Dirty

Dirty

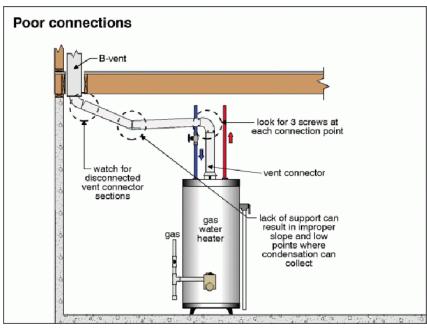
28. Condition: • Poor connections

Implication(s): Hazardous combustion products entering home | Equipment not operating properly

Location: Water heater Task: Secure/Attach/Seal

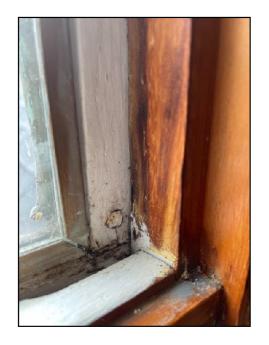
34. Condition: • Water damage **Location**: 2nd floor bedroom window

Task: Repair / replace

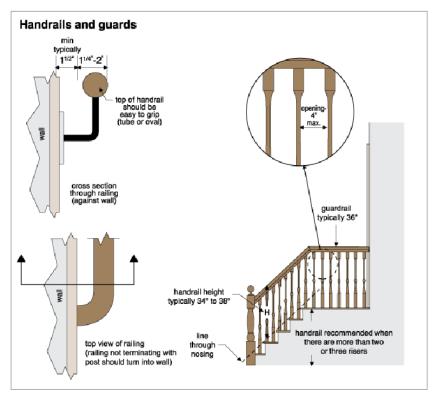
36. Condition: • Missing Implication(s): Fall hazard Location: Basement staircase

Missing
